NORTHLAND INSPECTIONS, LLC.

Inspection Report

Hello Townhouse!

Northland Inspections, LLC

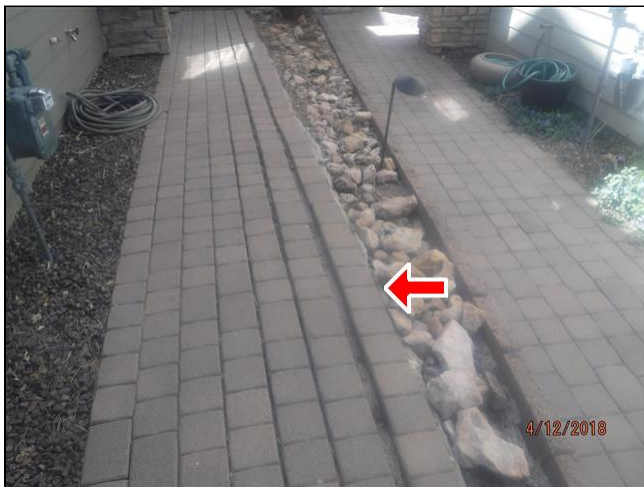
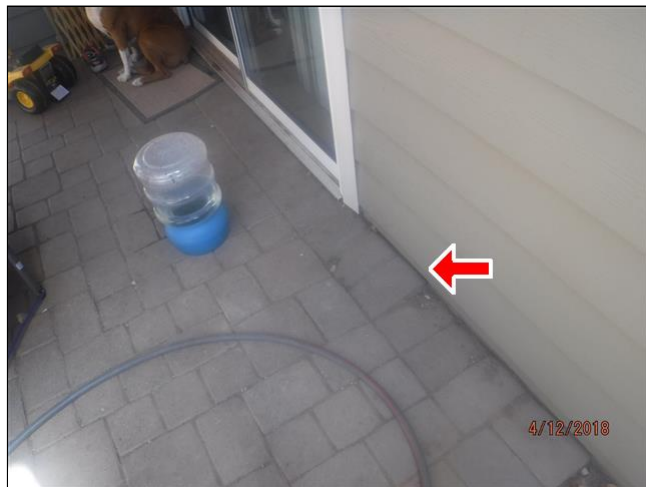
C.

The walkway to the front entry door and the rear patio were laid with pavers. Some of these pavers are loose, unlevel, and shifting away from the walkway. This may get to the point where it becomes a trip hazard. We recommend a competent person adjust and secure the pavers as needed.
- D. Fences and Gates
-

🔍 **C.** The walkway to the front entry door and the rear patio were laid with pavers. Some of these pavers are loose, unlevel, and shifting away from the walkway. This may get to the point where it becomes a trip hazard. We recommend a competent person adjust and secure the pavers as needed.

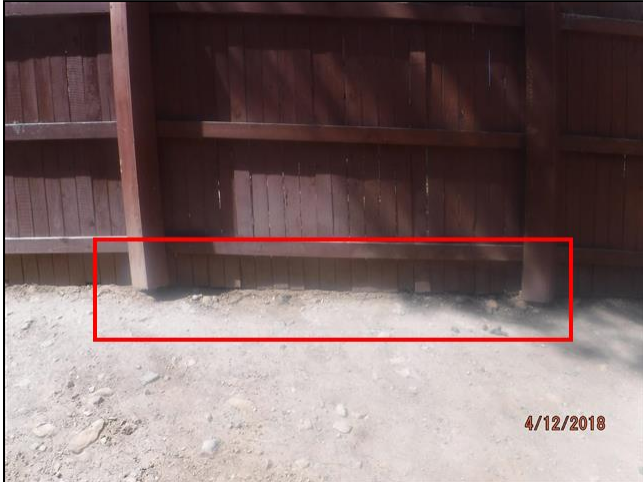
D.

The rear fence is currently acting as a retaining wall. These wooden fences were not designed for this purpose, and thus we recommend considering replacement fencing options or making arrangements to remove the back filled dirt.
- I. Paint and Stain
-

🔍 **D.** The rear fence is currently acting as a retaining wall. These wooden fences were not designed for this purpose, and thus we recommend considering replacement fencing options or making arrangements to remove the back filled dirt.

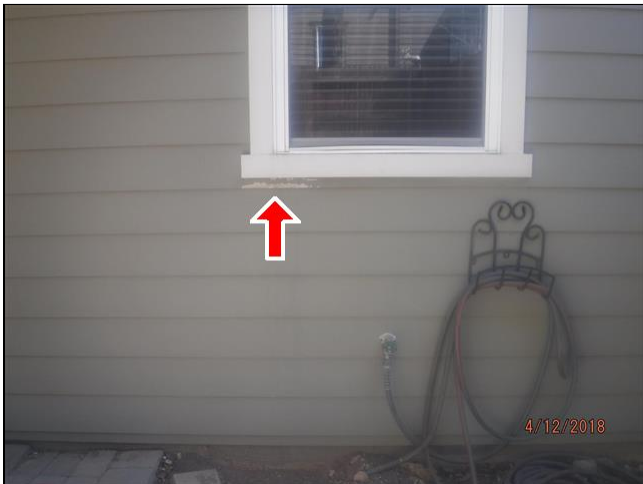
I.

Under the rear window at the kitchen sink, we observed a portion of paint missing from one board of siding. This appears to be dog damage as they jump toward the window. We recommend a competent painting person paint over this damage to create a uniform finish and fully protect the siding from the weather.

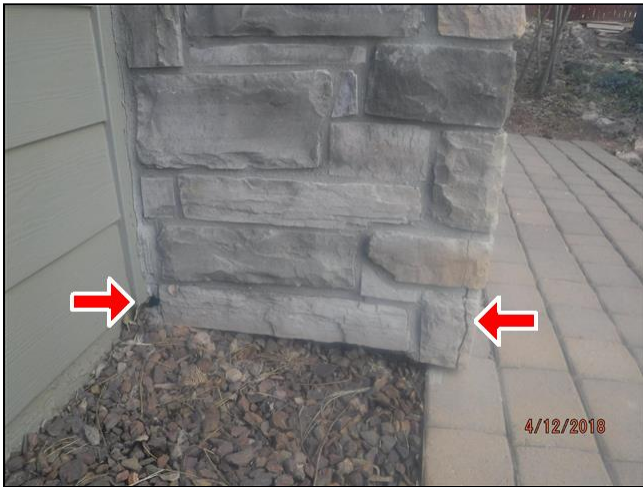
L.

We observed some minor cracking and missing grout at the masonry wall to the left of the front entry door. Most masonry will eventually come loose or crack at the grout. Maintaining and keeping the masonry sealed will prolong its life. We recommend a competent person seal all cracked masonry work around the home.

🔍 **L.** We observed some minor cracking and missing grout at the masonry wall to the left of the front entry door. Most masonry will eventually come loose or crack at the grout. Maintaining and keeping the masonry sealed will prolong its life. We recommend a competent person seal all cracked masonry work around the home.

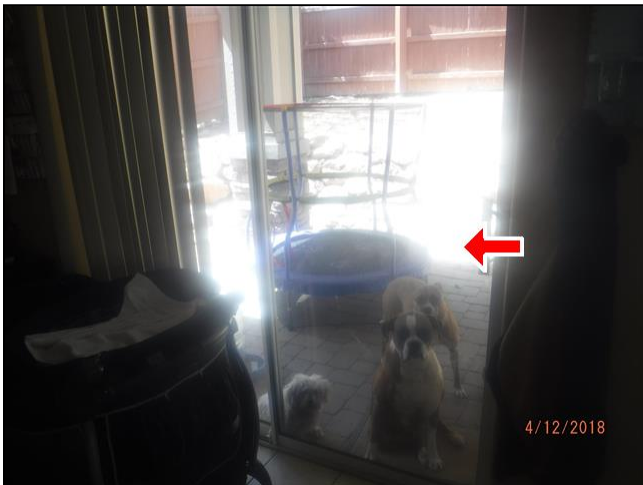
N.

We observed that the rear sliding glass door is missing a screen (likely because of the dogs). We recommend installing screens on the openable exterior windows where missing.

🔍 **N.** We observed that the rear sliding glass door is missing a screen (likely because of the dogs). We recommend installing screens on the openable exterior windows where missing.

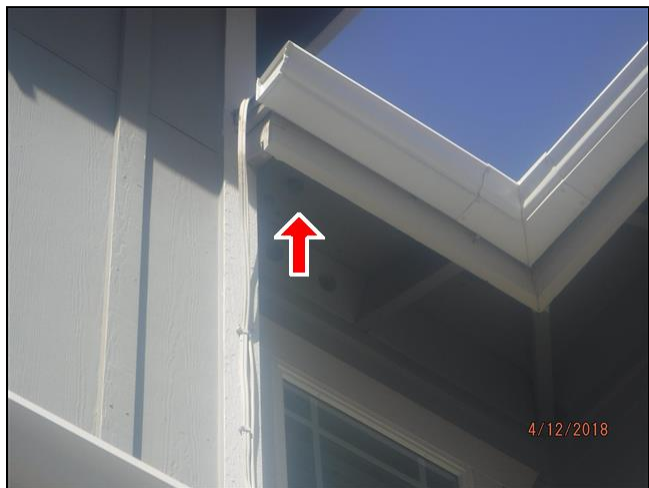
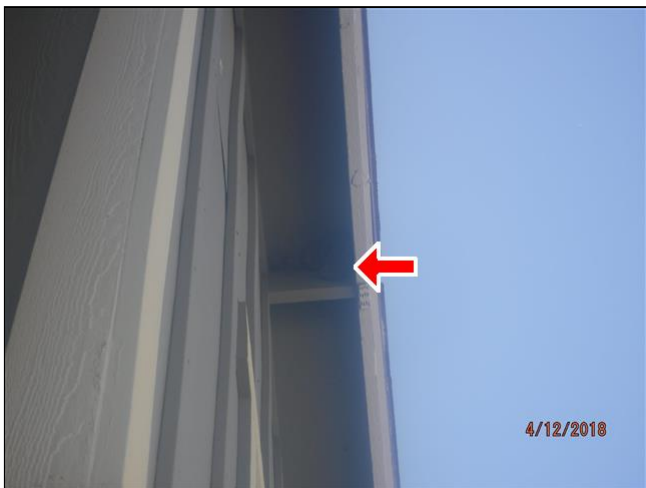
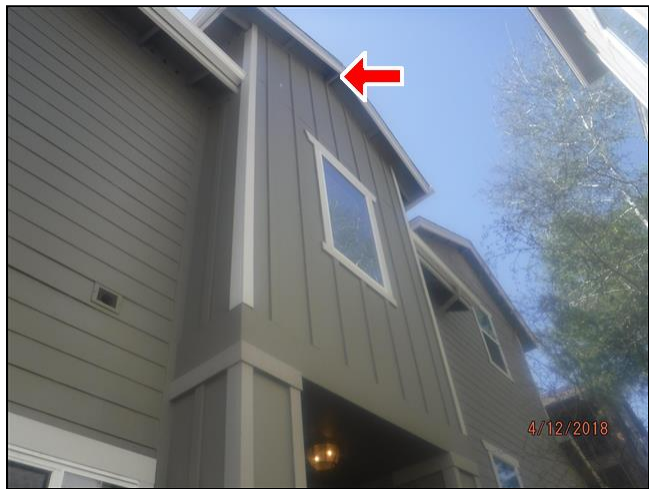
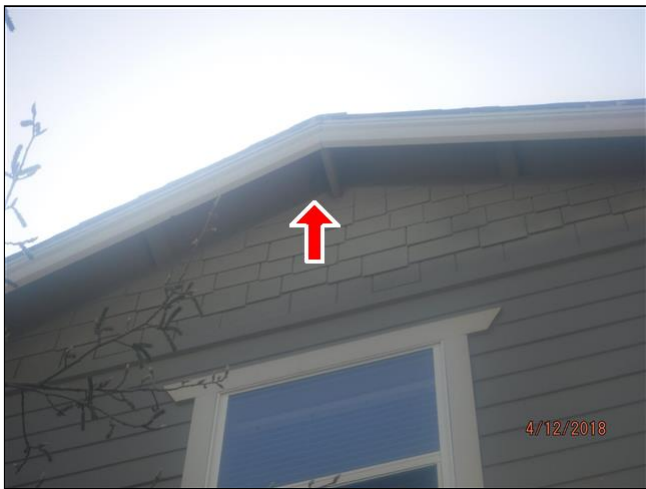
We observed several wasps's nests lodged in the eaves of all three visible sides of the home. We recommend a competent pest control person remove the nest and spray to keep the pests away.

P. We observed several wasps's nests lodged in the eaves of all three visible sides of the home. We recommend a competent pest control person remove the nest and spray to keep the pests away.

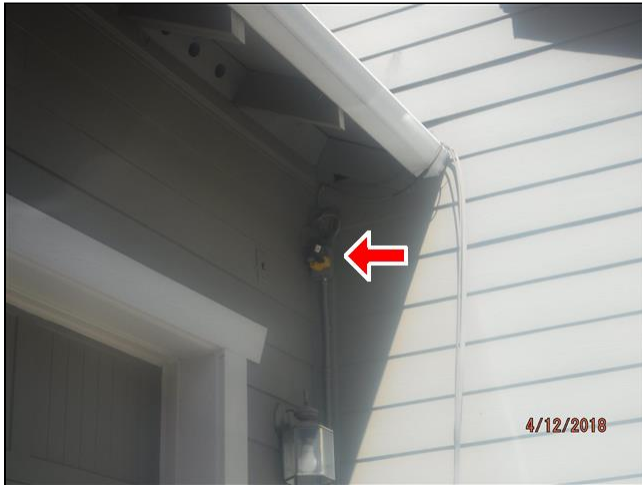
FYI: We observed an exterior receptacle under the eaves of the front right corner of the garage that is not weather covered for permanent use. For protection of the circuit, we recommend installing a more permanent weather cover over permanently used receptacles.

Q. FYI: We observed an exterior receptacle under the eaves of the front right corner of the garage that is not weather covered for permanent use. For protection of the circuit, we recommend installing a more permanent weather cover over permanently used receptacles.

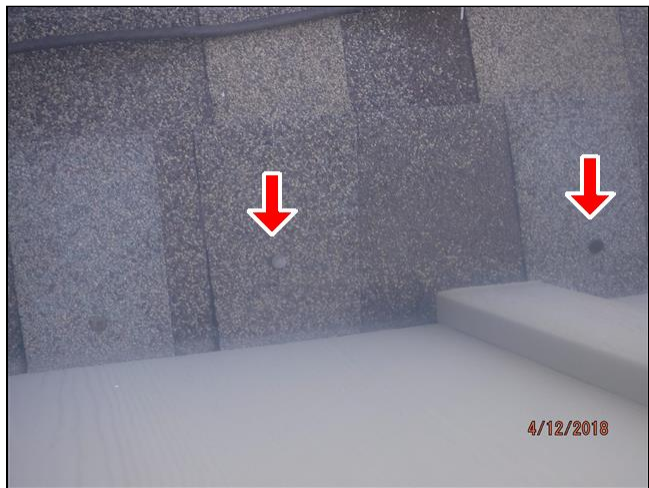
(1) At the lower roof of the front of the home, we observed some exposed nail heads along the top layer of shingles. In our experience, exposed nail heads are prone to rust which can weaken the integrity and the hold of the nails. This may lead to loosening of the nails. We recommend having a competent roofing person seal the nail heads to prevent damage from moisture.
-

A. (1) At the lower roof of the front of the home, we observed some exposed nail heads along the top layer of shingles. In our experience, exposed nail heads are prone to rust which can weaken the integrity and the hold of the nails. This may lead to loosening of the nails. We recommend having a competent roofing person seal the nail heads to prevent damage from moisture.

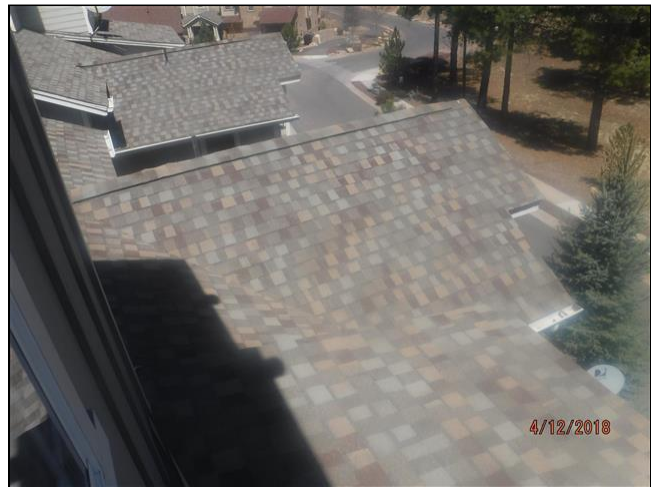
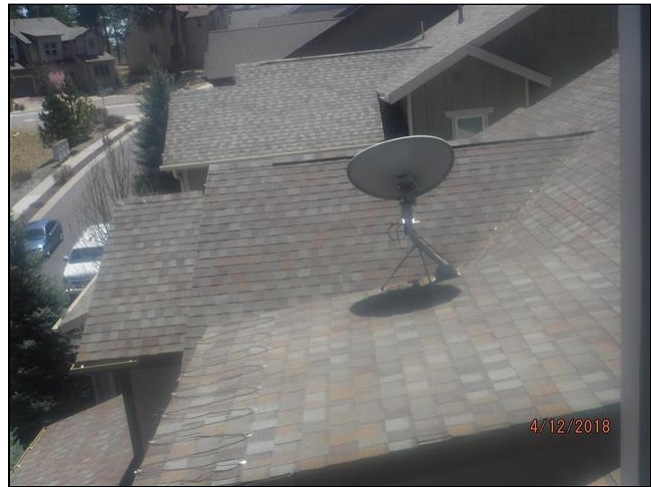
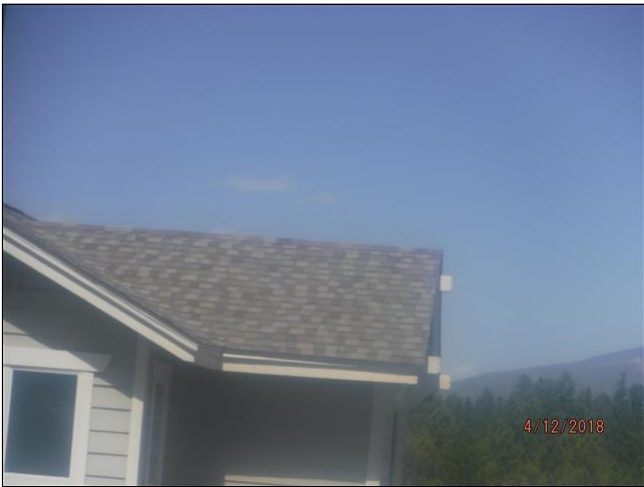
A.

(2) The roof coverings are in a typical condition for their age. Asphalt shingles typically have a 20-25 year expected life span. This home's shingles appear to have been installed in the past 15 years and are aging well. Client is advised to verify that roof maintenance is the association's responsibility and that they have the necessary funds for maintenance.

🔍 (2) The roof coverings are in a typical condition for their age. Asphalt shingles typically have a 20-25 year expected life span. This home's shingles appear to have been installed in the past 15 years and are aging well. Client is advised to verify that roof maintenance is the association's responsibility and that they have the necessary funds for maintenance.

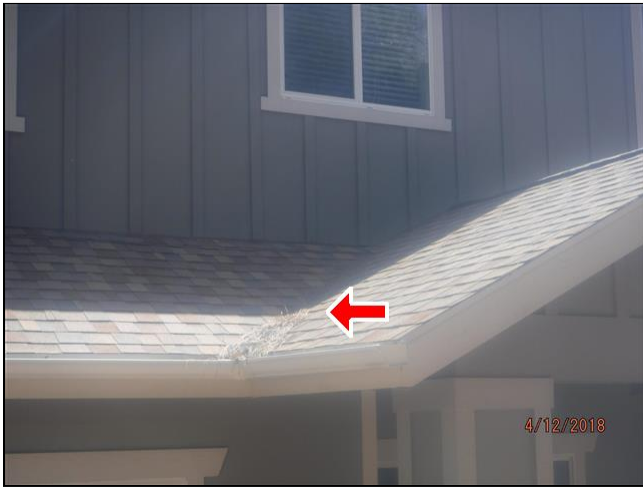
D. The pine trees around the perimeter of the home are dropping debris on the roofing. We recommend keeping the roofing clear of all vegetation to extend its life.

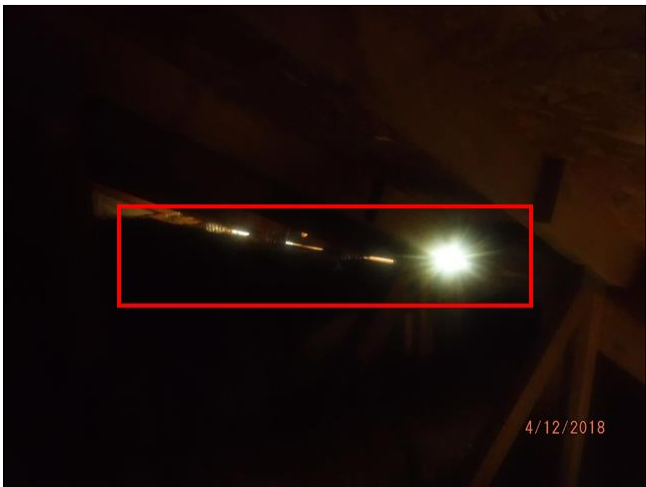
From the attic, we observed some daylight shining in through the roof framing. The gaps between framing may allow insects to enter the attic. Client is advised to have a competent person seal the gaps in the framing.

+ H. From the attic, we observed some daylight shining in through the roof framing. The gaps between framing may allow insects to enter the attic. Client is advised to have a competent person seal the gaps in the framing.

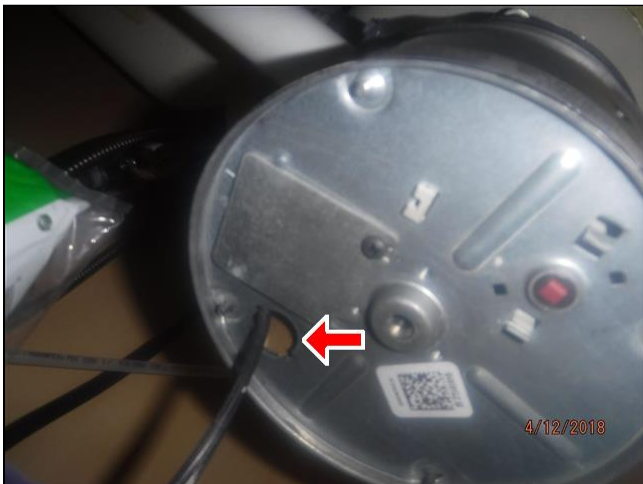
C.

The food disposal wiring is missing a romex connector that keeps the power cord secure in the bottom of the unit. This small plastic or metal connector is inexpensive and can be found at a local hardware store. We recommend a competent person install the connector.

🔍 **C.** The food disposal wiring is missing a romex connector that keeps the power cord secure in the bottom of the unit. This small plastic or metal connector is inexpensive and can be found at a local hardware store. We recommend a competent person install the connector.

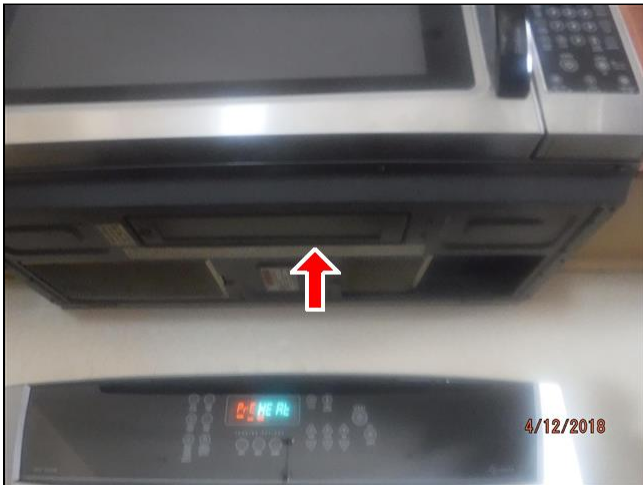
The cook top lights on the kitchen exhaust did not operate when we used their switch/button. We recommend having a competent person repair or replace the bulbs or fixtures as needed.

K. The cook top lights on the kitchen exhaust did not operate when we used their switch/button. We recommend having a competent person repair or replace the bulbs or fixtures as needed.

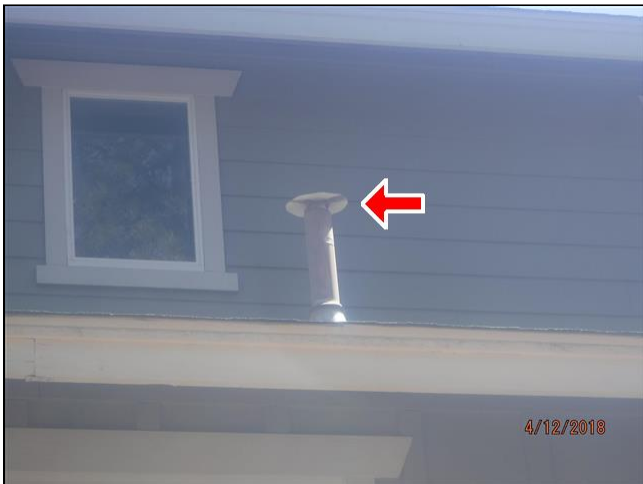
M. FYI: The dryer vent cap on the roof may allow flying pests into the dryer vent ductwork. There are several upgrade options for a damper or louvered cap that may be appropriate for this location.

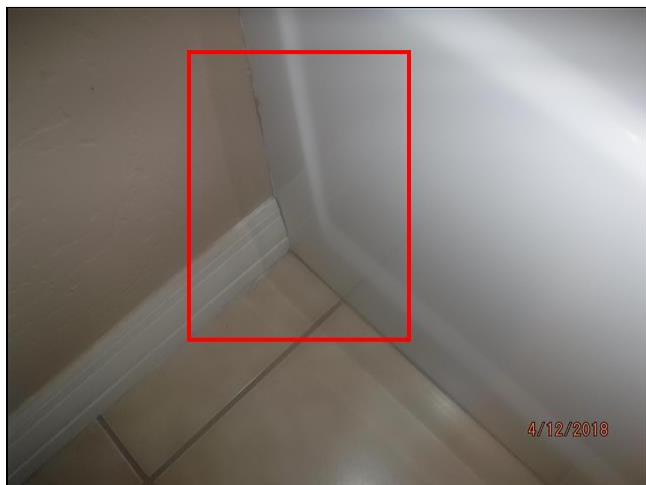
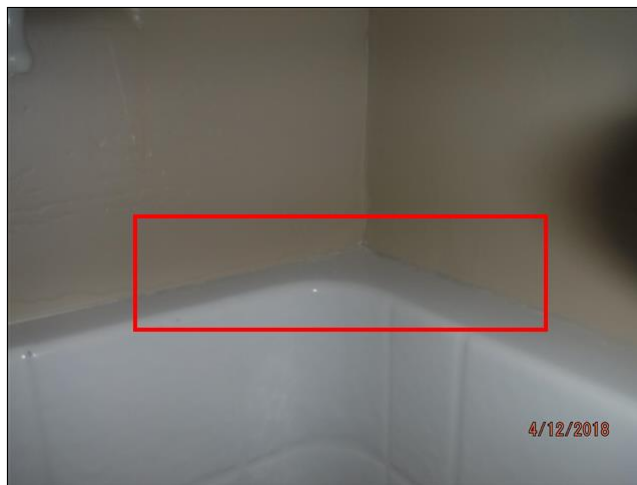
In the first story bathroom, we observed some gaps in the grout between the tile flooring and the bathtub as well as the top of the shower and the wall. It's important to keep a bathroom sealed. We recommend a competent person seal all gaps in the grout to keep water out and verify that the bathroom finish is in a dependable condition.

B.1. In the first story bathroom, we observed some gaps in the grout between the tile flooring and the bathtub as well as the top of the shower and the wall. It's important to keep a bathroom sealed. We recommend a competent person seal all gaps in the grout to keep water out and verify that the bathroom finish is in a dependable condition.

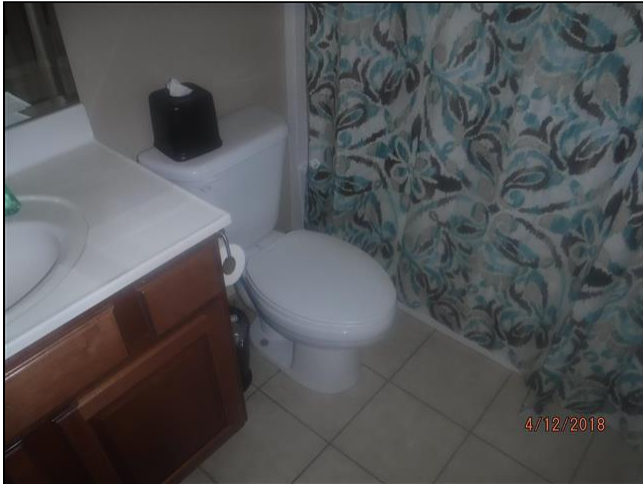
C.1.

The toilet in the first story bathroom is loose from the floor. If a toilet has been loose for some time, some repair may be needed which may include a new wax ring, caulking the toilet edges to a smooth surface, etc. We recommend a competent person repair as needed before securing the toilet.

+ **C.1.** The toilet in the first story bathroom is loose from the floor. If a toilet has been loose for some time, some repair may be needed which may include a new wax ring, caulking the toilet edges to a smooth surface, etc. We recommend a competent person repair as needed before securing the toilet.

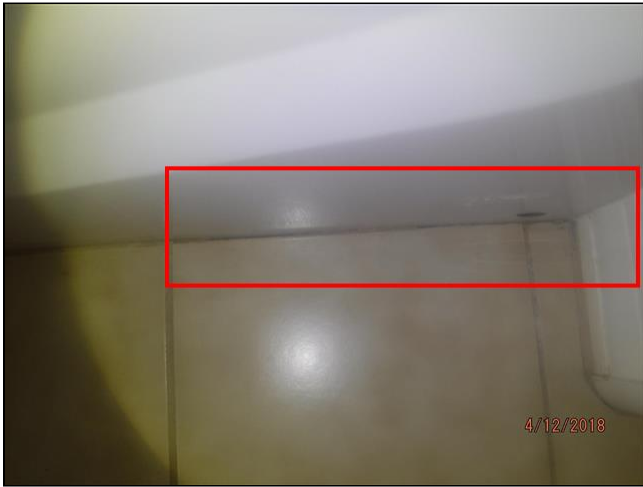
In the master bathroom, we observed some gaps in the grout between the tile flooring and the bathtub. It's important to keep a bathroom sealed. We recommend a competent person seal all gaps in the grout to keep water out and verify that the bathroom finish is in a dependable condition.

B.2. In the master bathroom, we observed some gaps in the grout between the tile flooring and the bathtub. It's important to keep a bathroom sealed. We recommend a competent person seal all gaps in the grout to keep water out and verify that the bathroom finish is in a dependable condition.

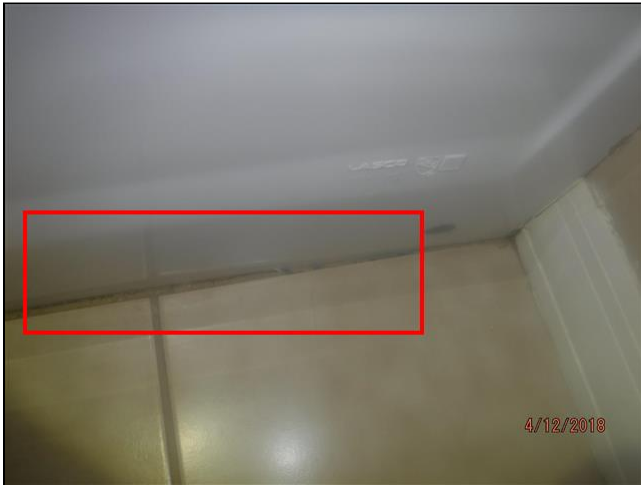
- 🔍 In the third story bathroom, we observed some gaps in the grout between the tile flooring and the bathtub. It's important to keep a bathroom sealed. We recommend a competent person seal all gaps in the grout to keep water out and verify that the bathroom finish is in a dependable condition.

B.3. In the third story bathroom, we observed some gaps in the grout between the tile flooring and the bathtub. It's important to keep a bathroom sealed. We recommend a competent person seal all gaps in the grout to keep water out and verify that the bathroom finish is in a dependable condition.

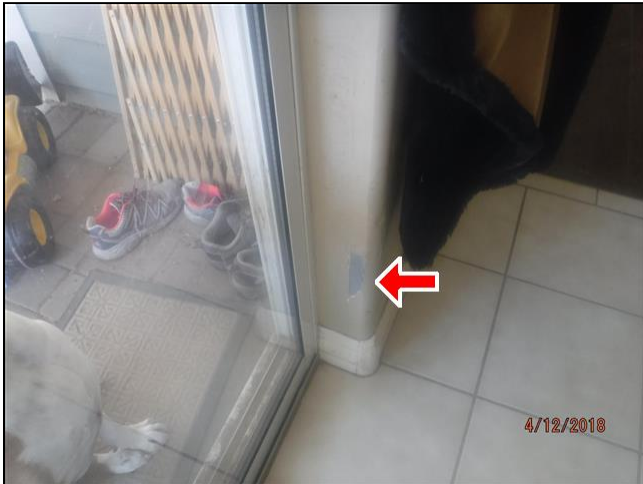
B. FYI: There is some damage to the wall near the rear sliding glass door. A competent drywall person can repair this damage.

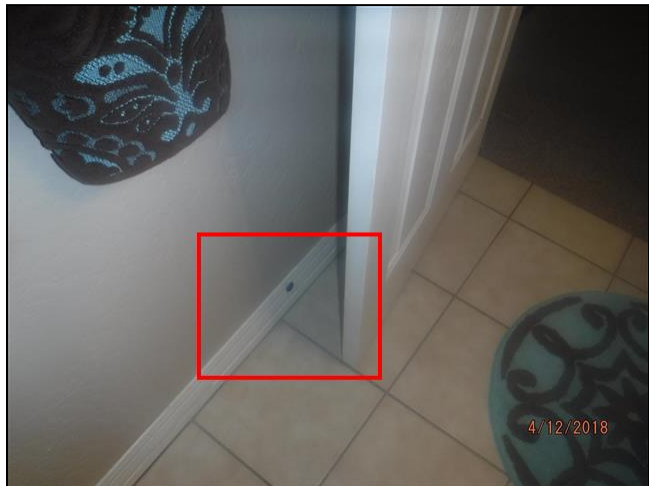
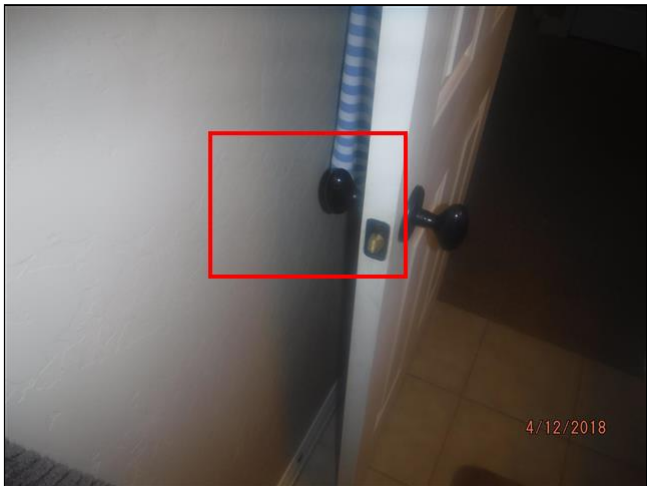
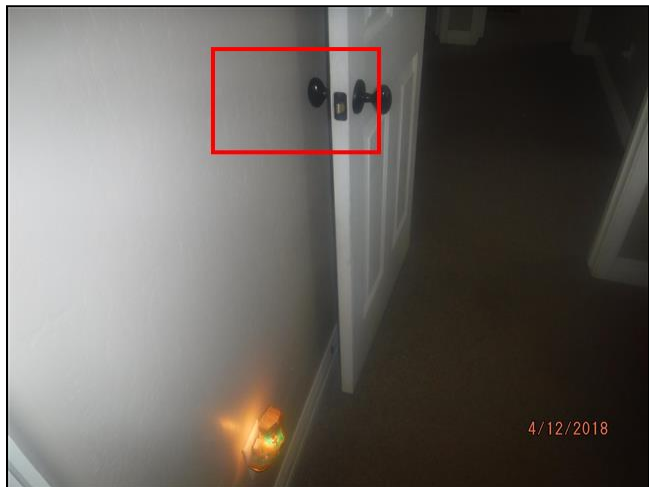
- 🔍 (1) Several doors are missing door stops which is causing damage to the wall behind them. Client is advised to install door stops where missing and repair any damage to the walls that the doors may have caused.
- 🔍 (2) The doors to the first story bathroom and the storage closet in the master bathroom do not latch closed. We recommend a competent person adjust, repair, or replace the doors or their hardware as needed.
- 🔍 (3) We observed that the master bedroom door rubs on its frame. We recommend repairing or adjusting as needed.

H. (1) Several doors are missing door stops which is causing damage to the wall behind them. Client is advised to install door stops where missing and repair any damage to the walls that the doors may have caused.

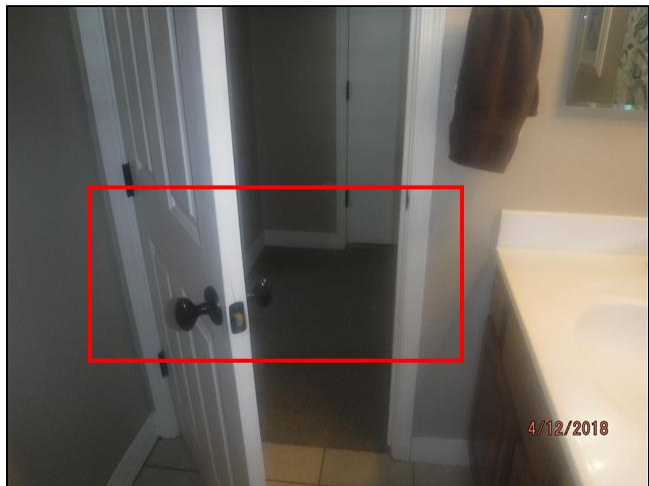
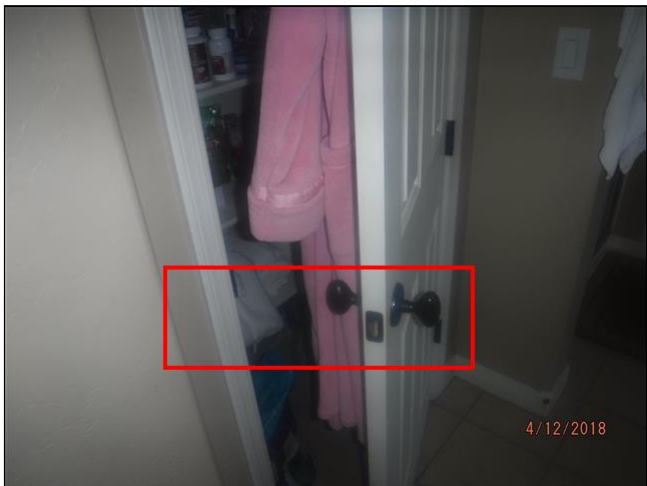
H. (2) The doors to the first story bathroom and the storage closet in the master bathroom do not latch closed. We recommend a competent person adjust, repair, or replace the doors or their hardware as needed.

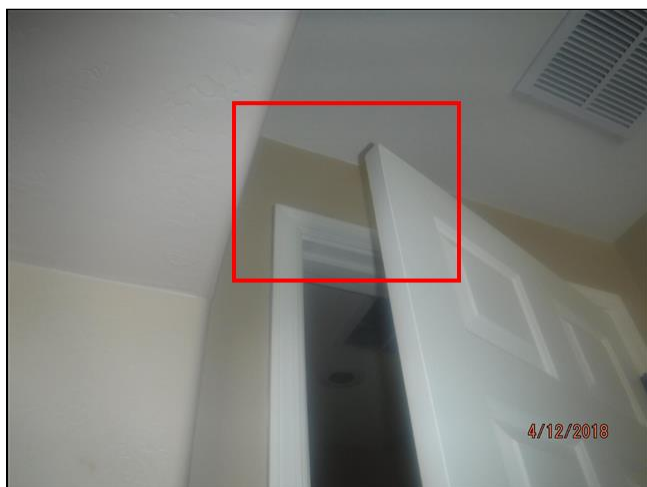
H.

🔍 (3) We observed that the master bedroom door rubs on its frame. We recommend repairing or adjusting as needed.

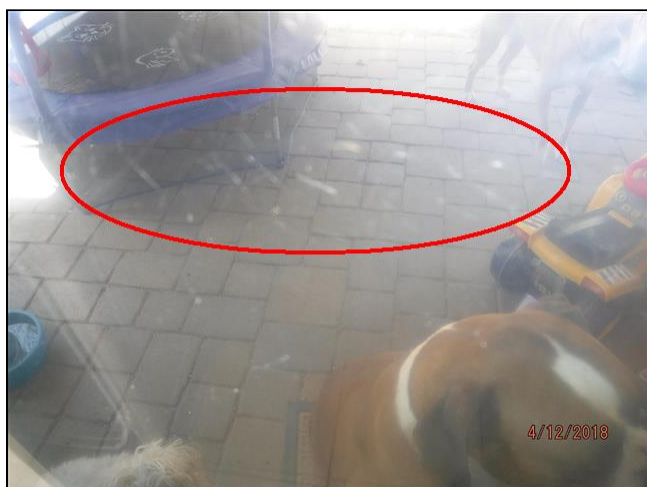
(1) The rear sliding glass door has scratches on the exterior glazing from the dogs jumping on the door. Client is advised to have a competent person replace the glass in the door as needed.

+ J. (1) The rear sliding glass door has scratches on the exterior glazing from the dogs jumping on the door. Client is advised to have a competent person replace the glass in the door as needed.

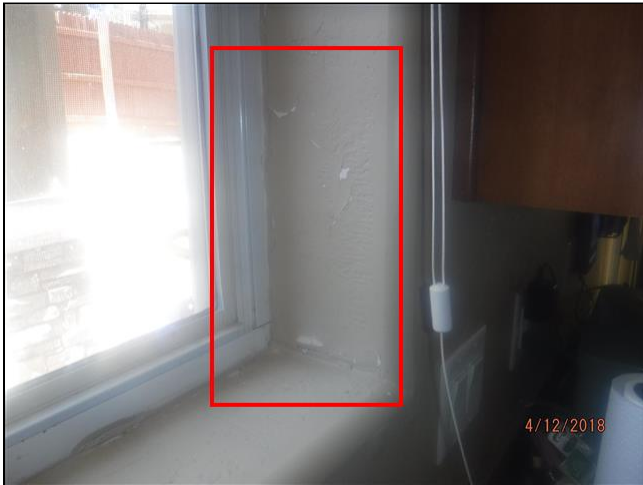
J.

- 🔍 (2) At the window sill over the kitchen sink, we observed some worn paint likely from a combination of sun shine and condensation during the different seasons. We recommend a competent paint person seal the area to maintain a protective layer at this location.
- 🔍 (3) While closing some windows in the home, we heard the spring in the sliding mechanism vibrate. This sound typically occurs when the spring falls out of place. We did not observe any springs fall out of place in this home. Some springs may be loose and may benefit from a competent window person securing or repairing the springs as needed.

🔍 (2) At the window sill over the kitchen sink, we observed some worn paint likely from a combination of sun shine and condensation during the different seasons. We recommend a competent paint person seal the area to maintain a protective layer at this location.

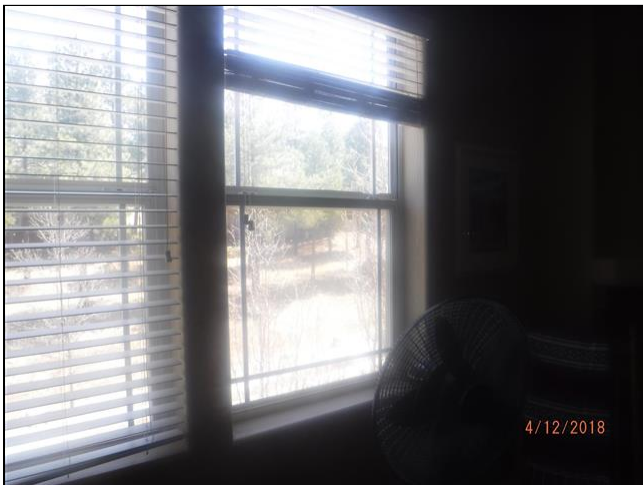
J.

🔍 (3) While closing some windows in the home, we heard the spring in the sliding mechanism vibrate. This sound typically occurs when the spring falls out of place. We did not observe any springs fall out of place in this home. Some springs may be loose and may benefit from a competent window person securing or repairing the springs as needed.

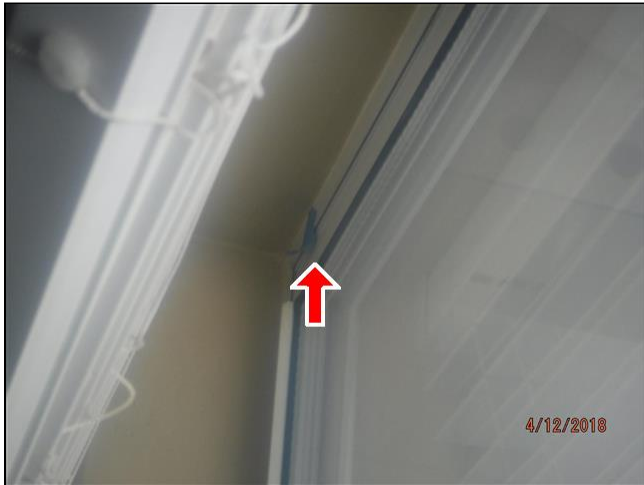
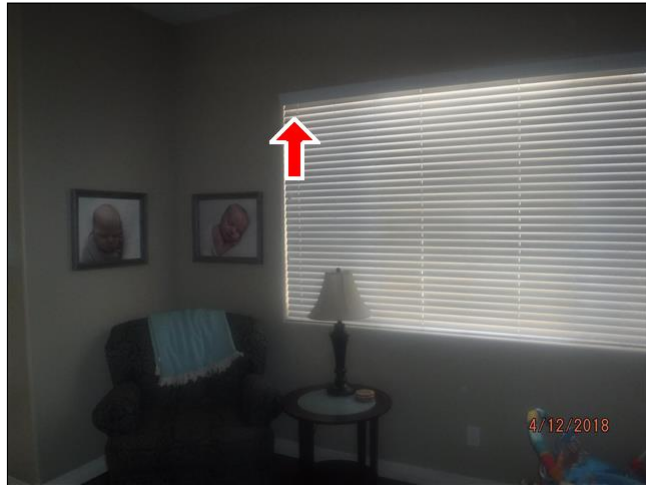
J.

(4) At the large rear window in the great room, we observed a piece of blue scotch tape in the top left corner of the window. This tape is typically used to mark an item needing repair in a new home walkthrough. We could not observe this area because of the blinds. Client is advised to remove the blinds and determine why the blue tape was placed in this location.

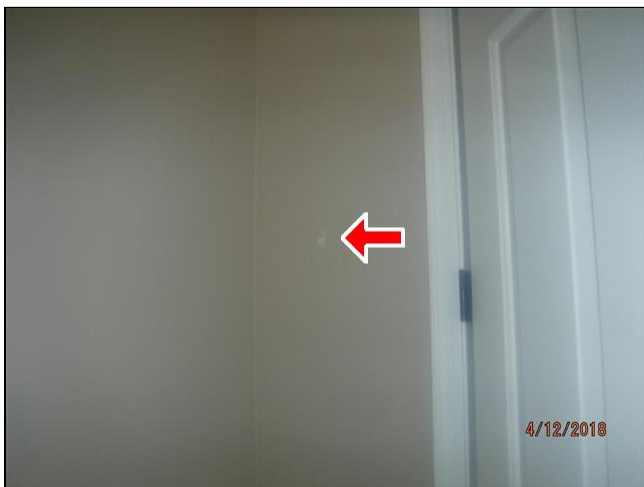
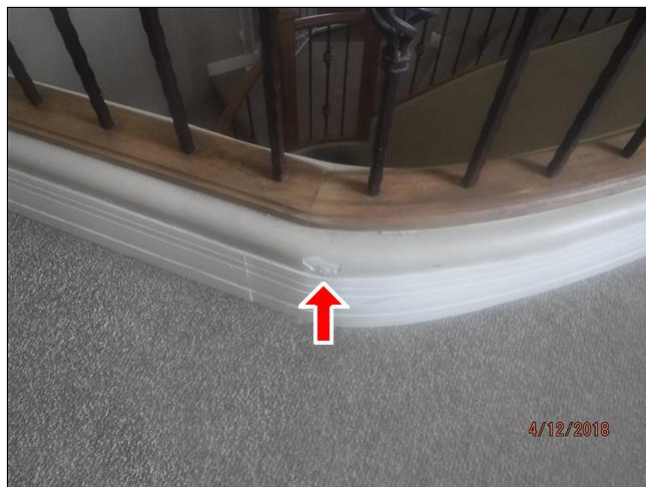
L. Throughout some of the rooms of the home, we found some minor cosmetic concerns such as paint missing from a ding in the wall and paint missing from some trim in the loft. Repair of these cosmetics is optional. Client is advised to verify that all cosmetic concerns are suitable for their expected appearance of the home.

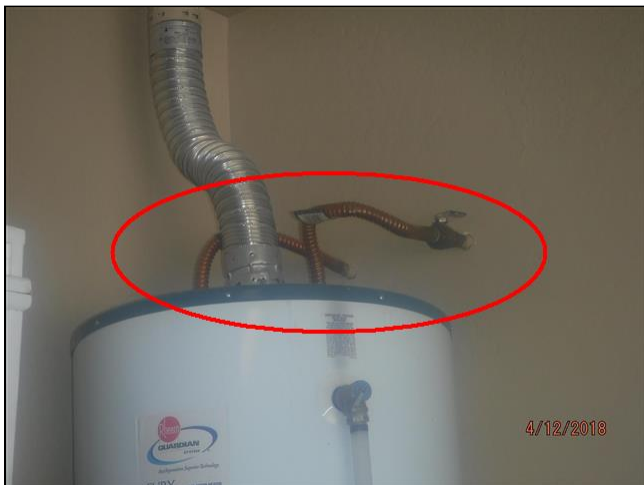
(1) In the garage, we observed some water supply piping above the water heater that is not insulated. In below freezing temperatures, garages can get cold enough to freeze water. We recommend a competent person insulate all exposed water pipes to keep them from freezing.

+ A. (1) In the garage, we observed some water supply piping above the water heater that is not insulated. In below freezing temperatures, garages can get cold enough to freeze water. We recommend a competent person insulate all exposed water pipes to keep them from freezing.

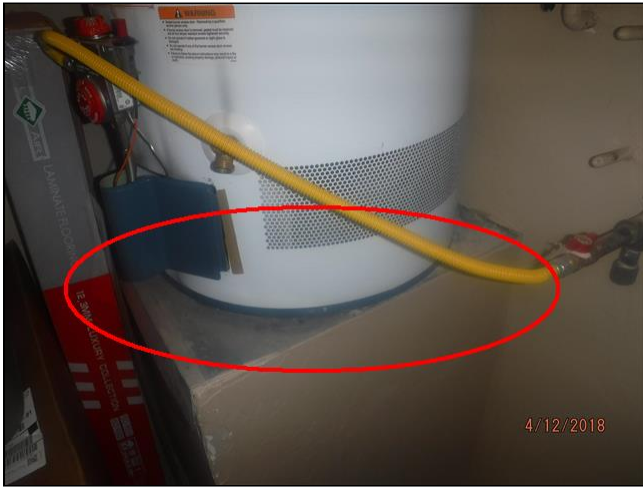
E.

- 🔍 (2) Having a drip pan installed under a water heater is beneficial because all water heaters leak when they reach the end of their serviceable life. A drip pan installed under a water heater is required only when the unit is installed inside the home. We recommend considering installing a drip pan to prevent a water mess when this water heater leaks.

🔍 (2) Having a drip pan installed under a water heater is beneficial because all water heaters leak when they reach the end of their serviceable life. A drip pan installed under a water heater is required only when the unit is installed inside the home. We recommend considering installing a drip pan to prevent a water mess when this water heater leaks.

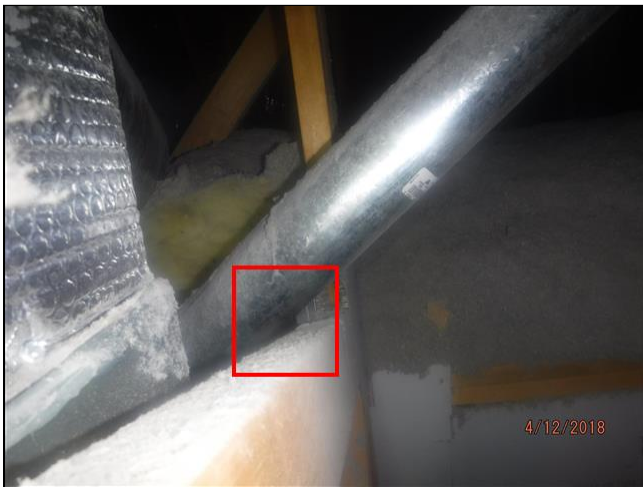
- 🔍 The water heater's flue pipe was observed to be too close to a combustible material (within one inch of it) where it passes a roof joist in the attic. We recommend a competent person repair as needed according to the current standards of the industry.

🔍 F. The water heater's flue pipe was observed to be too close to a combustible material (within one inch of it) where it passes a roof joist in the attic. We recommend a competent person repair as needed according to the current standards of the industry.

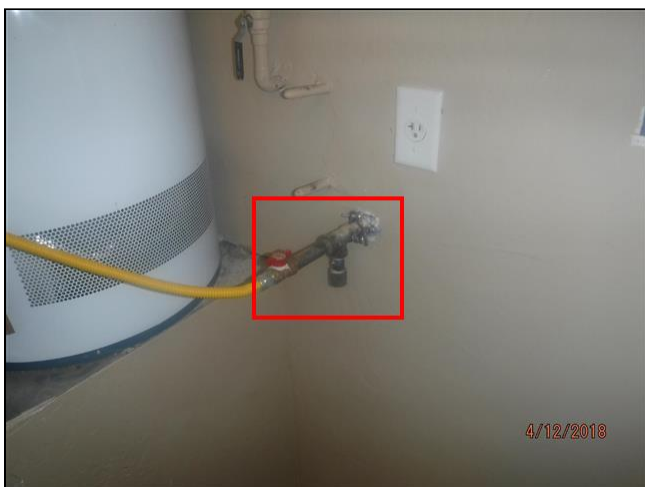
I. (1) At the furnace and the water heater, we observed that the sediment trap installed into the supply gas lines was done incorrectly. A sediment trap is a leg of piping that extends downward vertically from the supply line as close to the appliance as possible. It is designed to catch any sediment that makes its way into the gas line (see picture below). Client is advised to have a competent plumbing person re-install the sediment traps into the appliances' supply lines according to the current standards of the industry.

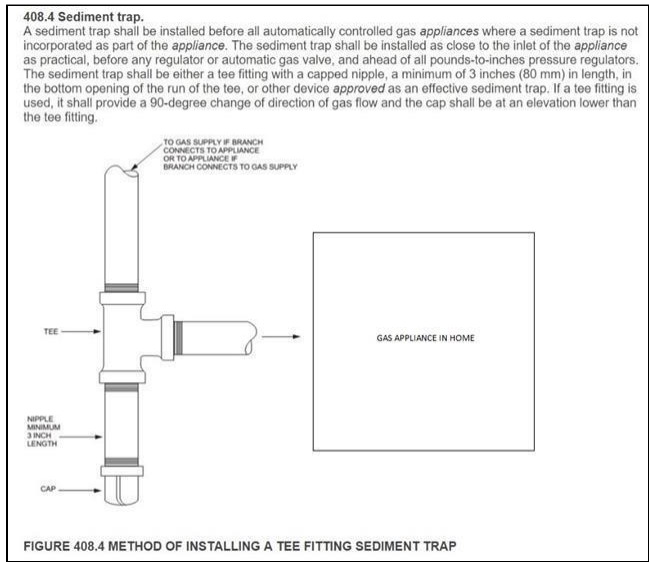
(2) Explanation of the diagram: The gas supply to the appliance enters the Tee from above then makes a 90 degree turn into the appliance. The trap at the bottom of the diagram will catch any sediment or larger particles that are mixed in with the gas. This trap keeps all non-gas materials out of the appliance to increase the longevity of the appliance.

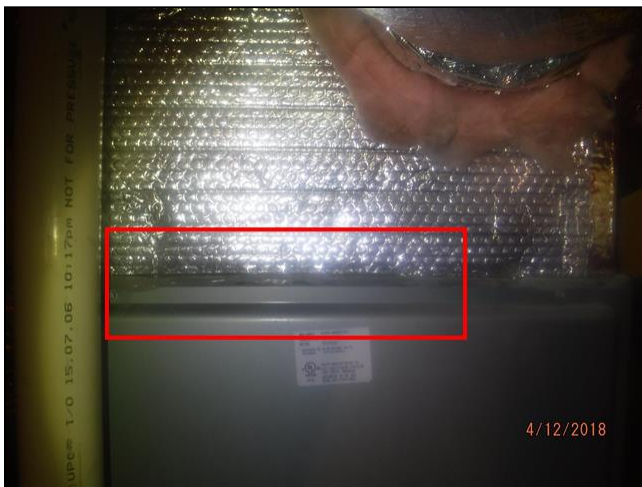
B.

(2) While at the furnace/air handler in the attic, we felt some warm air coming out of a gap between the plenum and the air handler. We recommend a competent heating and cooling person seal this gap to maintain all of the conditioned air blown through the plenum.

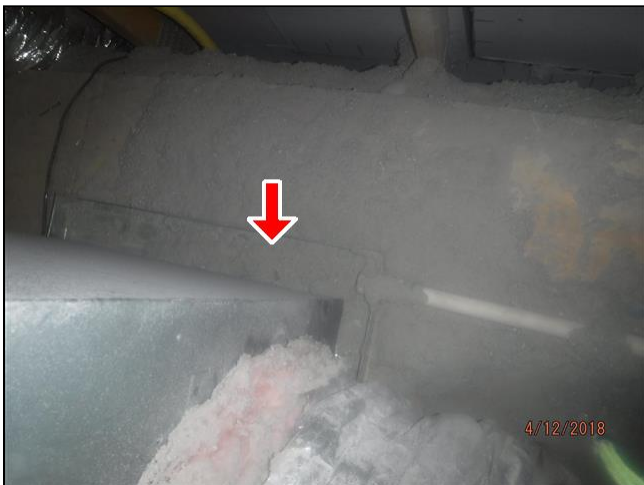
C.

(2) We observed insulation in the condensate drip pan. If condensate were to enter the pan, it could move the insulation to the drain hole and block the drain. This may lead to the pan backing up, overflowing, and leaking through the ceiling. We recommend a competent person clean all insulation out of the pan.

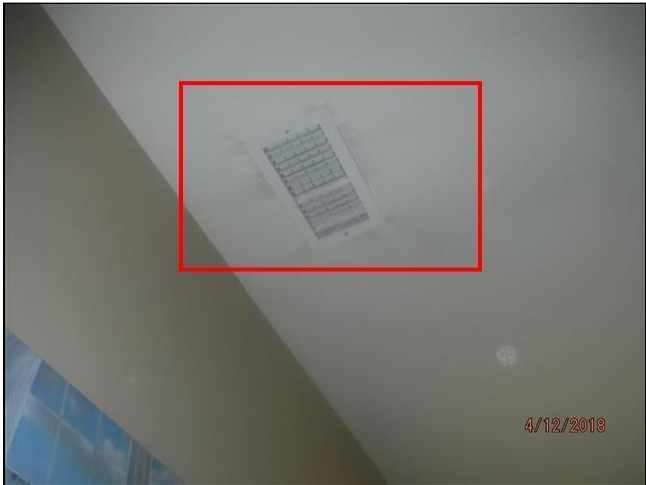
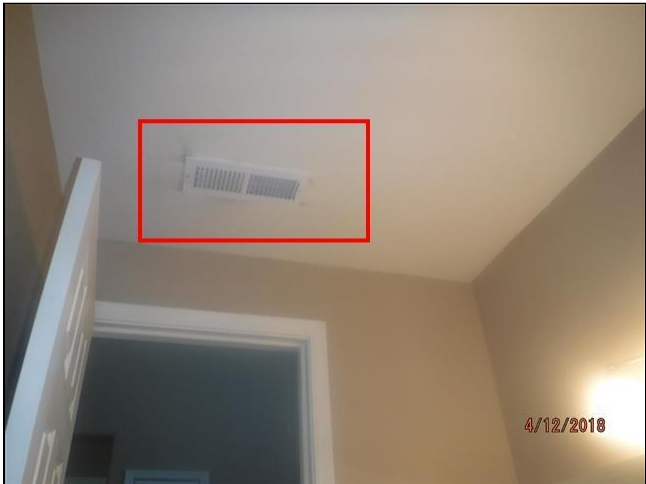
G.

We observed soot (a black powdery carbon substance produced by the incomplete burning of fuels) around several heat registers throughout the home. This can be an effect of burning candles or smoking cigarettes often, or it can be a sign that the heat exchanger in the furnace is cracked or damaged. We recommend a competent heating and cooling person evaluate the furnace and verify that it is operating in a safe and dependable condition.

+ **G.** We observed soot (a black powdery carbon substance produced by the incomplete burning of fuels) around several heat registers throughout the home. This can be an effect of burning candles or smoking cigarettes often, or it can be a sign that the heat exchanger in the furnace is cracked or damaged. We recommend a competent heating and cooling person evaluate the furnace and verify that it is operating in a safe and dependable condition.

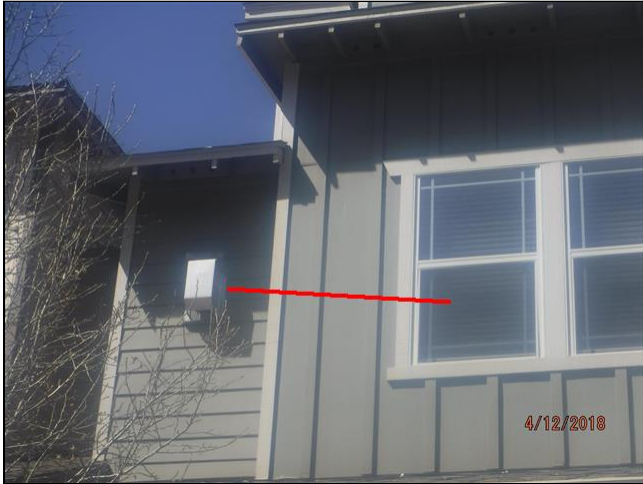
I. FYI: On the front of the home, there is a vent for the gas fireplace in the master bedroom. This vent exhausts carbon monoxide that is harmful to humans. There is a window that is within 10 feet of the vent. Client is advised to verify that this window is never opened when the gas fireplace is operated. This would create a **Safety Hazard** by allowing carbon monoxide into the home.
