Energy Scan Report

Inspection Address:
1000 N. Anywhere, Washburn, AZ

Energy Scan Report #:
04.01.2008

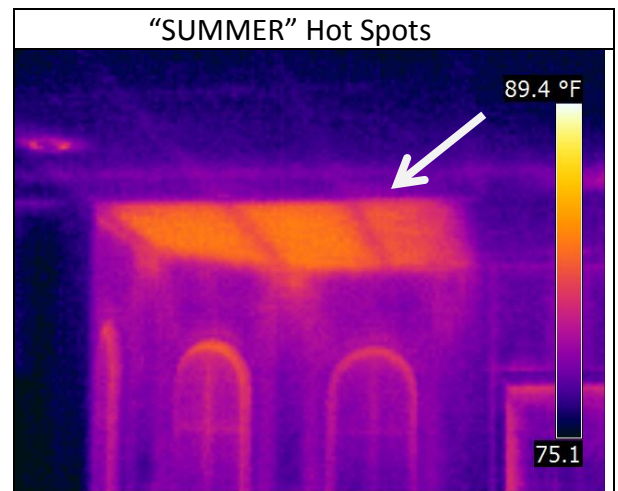
The blower door which we used during this scan helps to highlight areas of significant air leakage around doors, windows and exterior penetrations. Images taken from around these penetrations often show streaking (see white arrows) which is directly associated with air leakage or drafts.

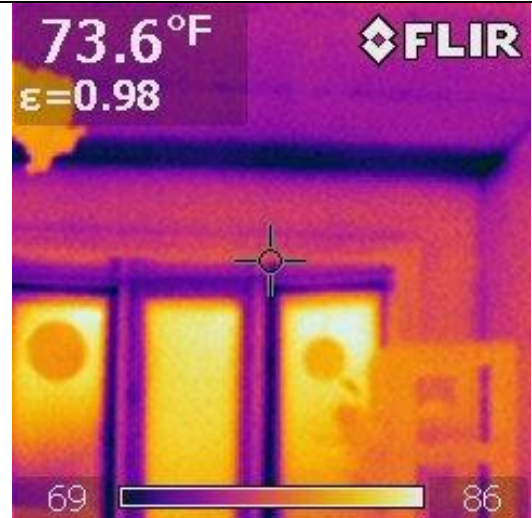
LOCATION: **Office / Library**

WHERE: **Ceiling**

CONDITION: (Loose/Missing) The thermal pattern is indicative of loose or missing insulation.

RECOMMENDATION: We recommend repair as an Optional Repair.

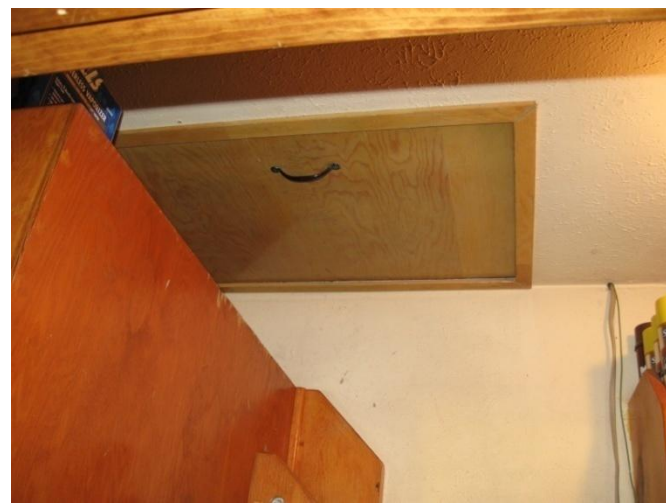
LOCATION: **pantry**

WHERE: **Ceiling**

CONDITION: (Attic Access) The attic access cover appears to be lacking proper insulation.

RECOMMENDATION: We recommend further review and repair as an Optional Repair.

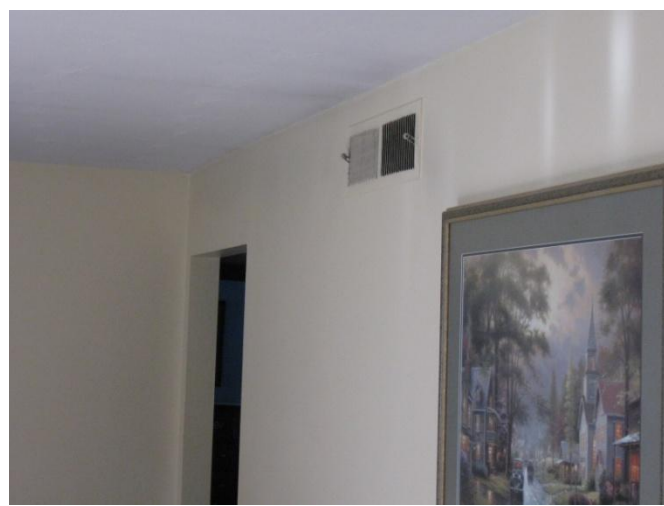
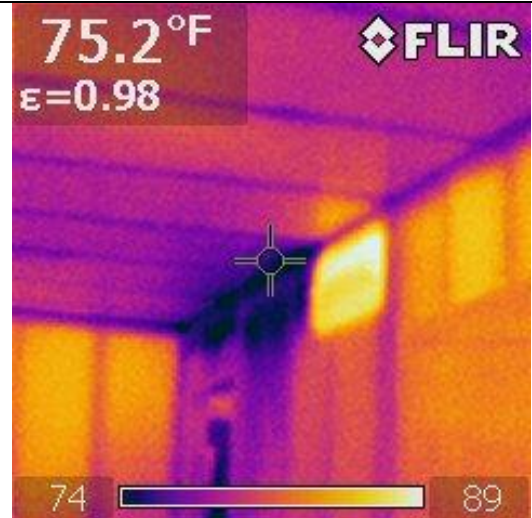
LOCATION: **Living Room**

WHERE: **Rear Wall**

CONDITION: (Loose/Missing) The thermal pattern is indicative of loose or missing insulation.

RECOMMENDATION: We recommend further review and repair as an Optional Repair.

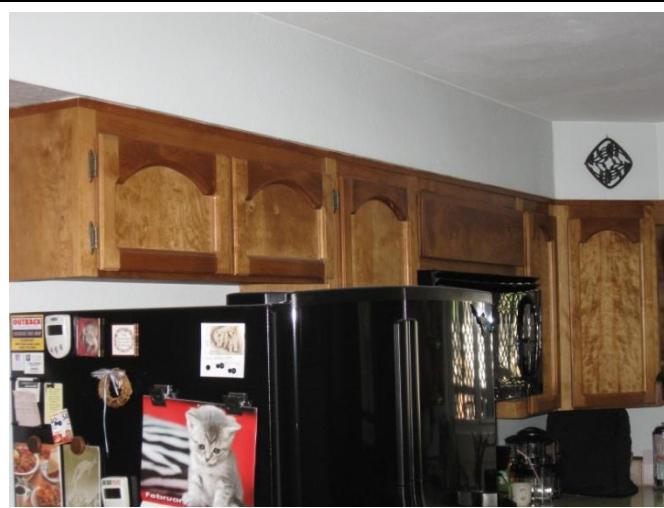
LOCATION: **Kitchen**

WHERE: **Left Wall**

CONDITION: (Loose/Missing) The thermal pattern is indicative of loose or missing insulation.

RECOMMENDATION: We recommend further review and repair as needed. Choose an item.

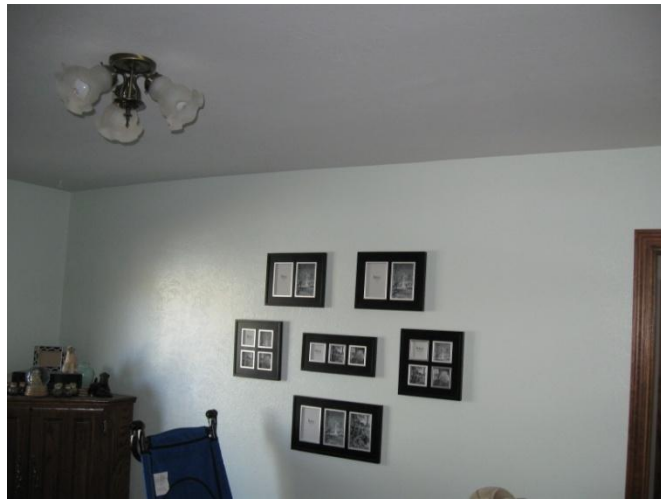
LOCATION: **Bedroom**

WHERE: **Right Wall**

CONDITION: (Loose/Missing) The thermal pattern is indicative of loose or missing insulation.

RECOMMENDATION: We recommend further review and repair as an Optional Repair.

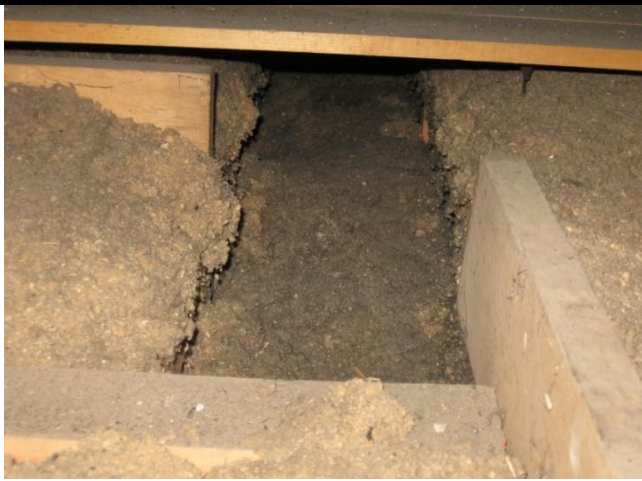
Wall/attic cavity needs filling with insulation

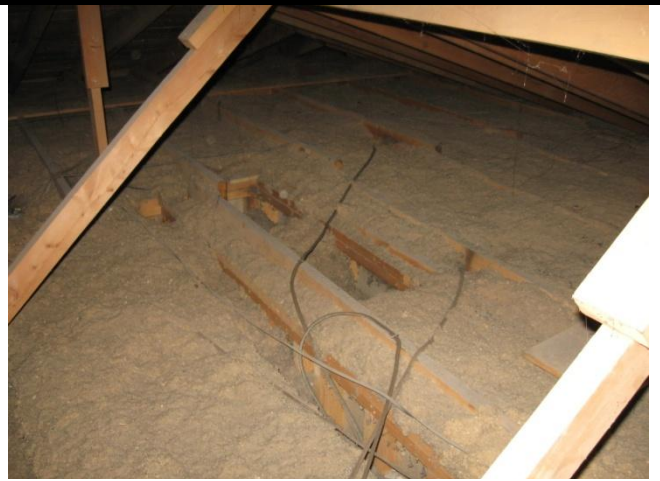
Area between walls needs sealing in attic

3. Seal or better insulate the area between the plumbing walls between the bathrooms.
4. Seal and insulate the attic access hatch.
5. Seal and insulate the drop down ceiling soffit areas in the kitchen.
6. Have a competent electrical person raise up any electrical boxes to above the level of the new insulation.
7. Consider installing insulation shields at the eaves so the blown in insulation will allow any exterior air from the soffits to ventilate the attic. If ventilation is added at a later date, this will be especially helpful.
8. Consider adding additional ventilation if the attic area is too hot after the insulation is added.

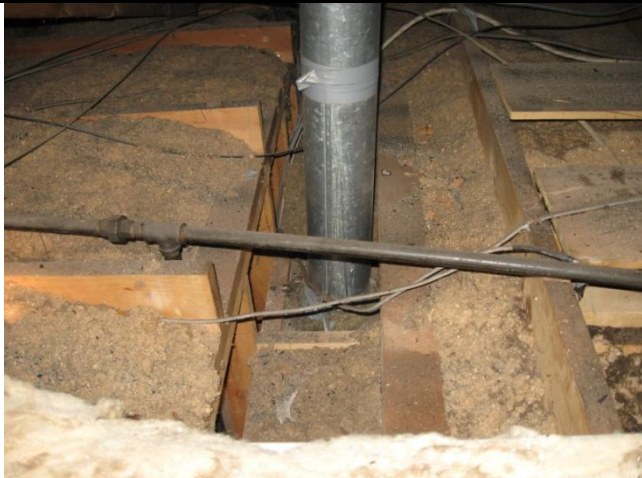
Kitchen drop ceiling soffit needs insulation
