NORTHLAND INSPECTIONS, LLC.

Inspection Report

Hello Townhouse!

Northland Inspections, LLC

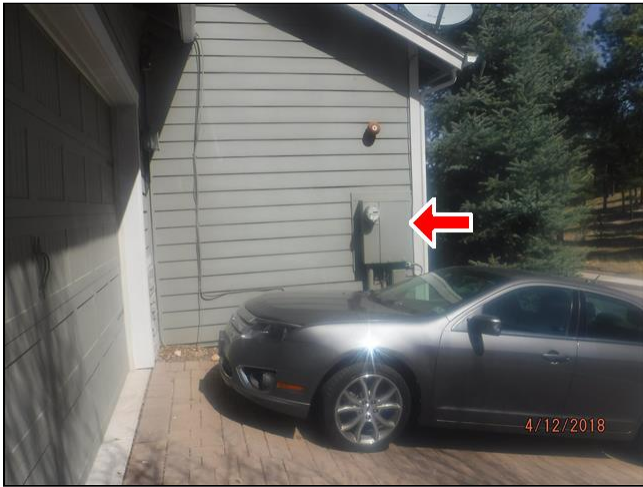
A. FYI: The main electrical panel is located at the exterior left side of the home.

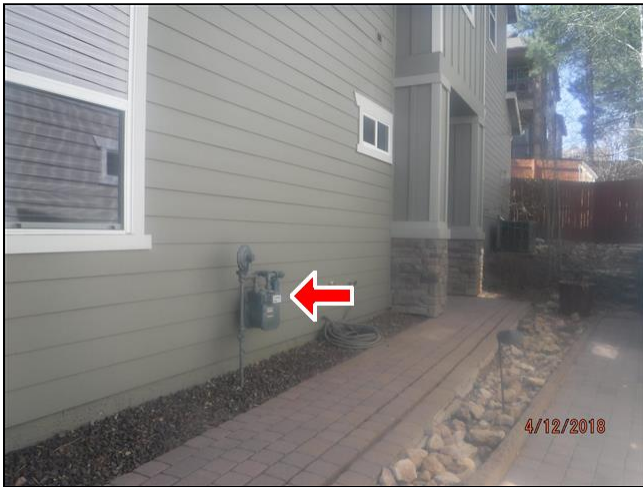
B. FYI: The gas meter is located at the exterior right side of the home.

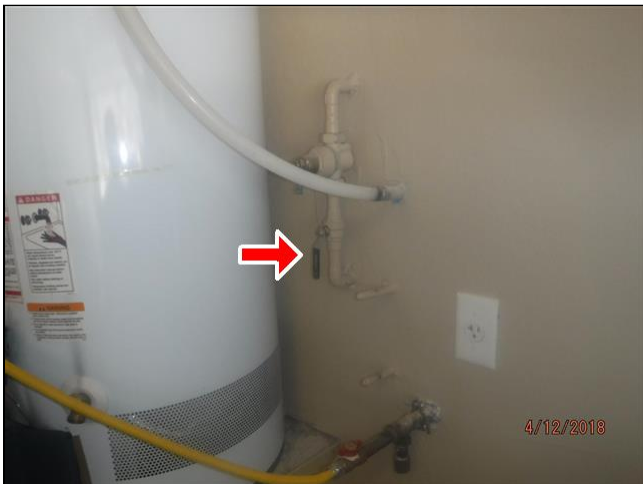
C. FYI: The main water shutoff is located in the garage near the water heater.

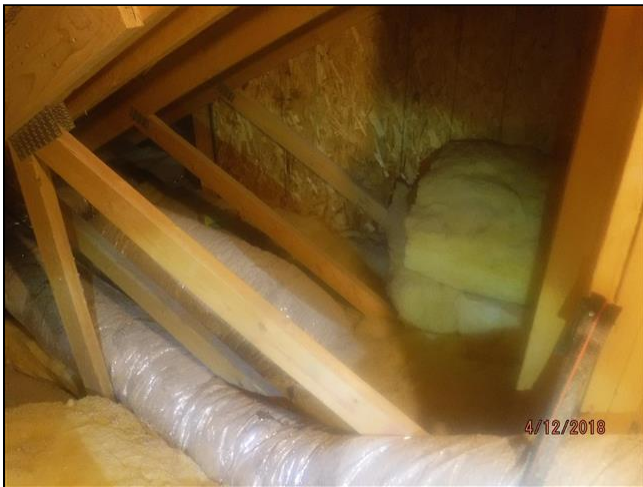
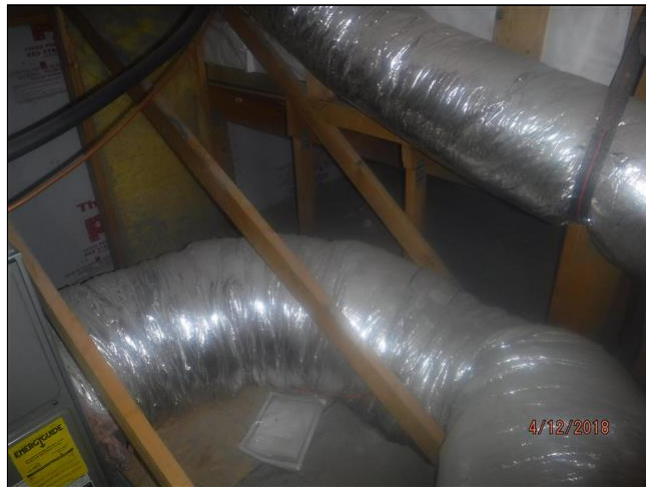
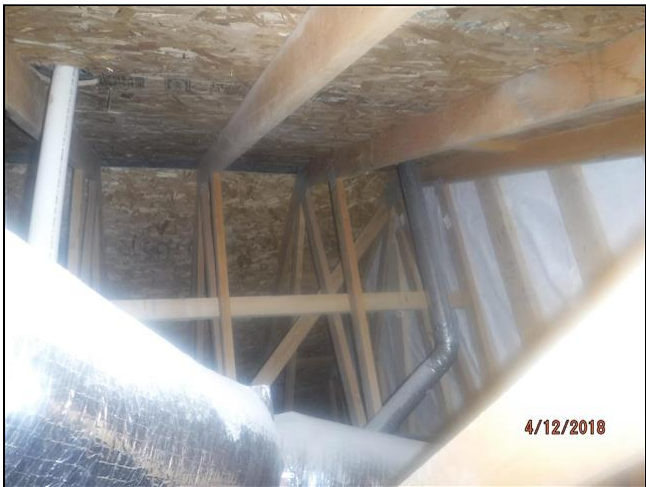
F. We observed no concerns in the attic regarding the structure of the roof.

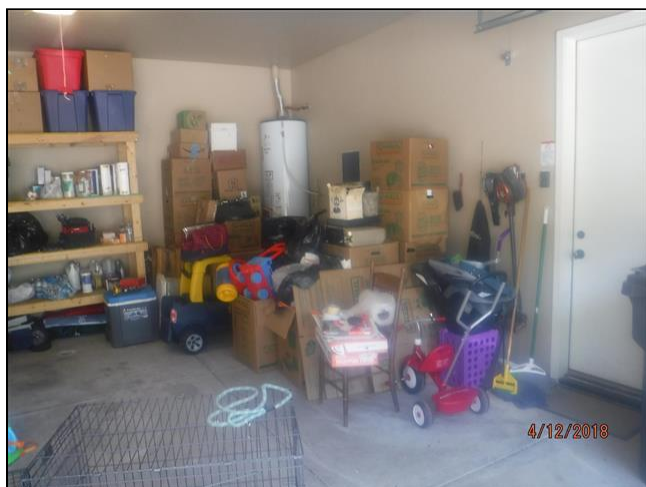
A. The occupant's personal items were still in the garage during the inspection. We may have missed some reportable items because we could not see all of the garage.

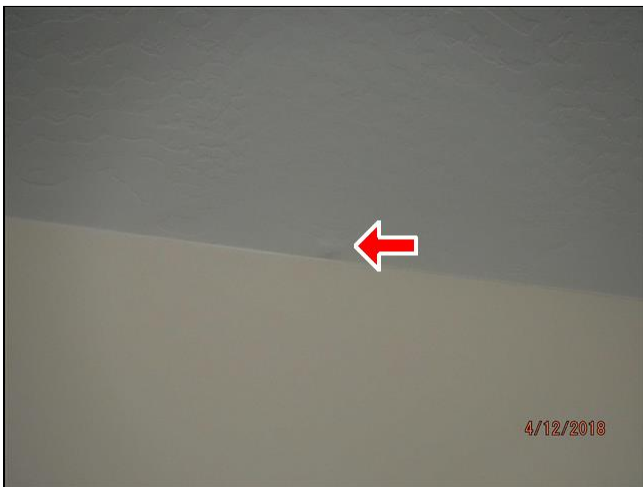
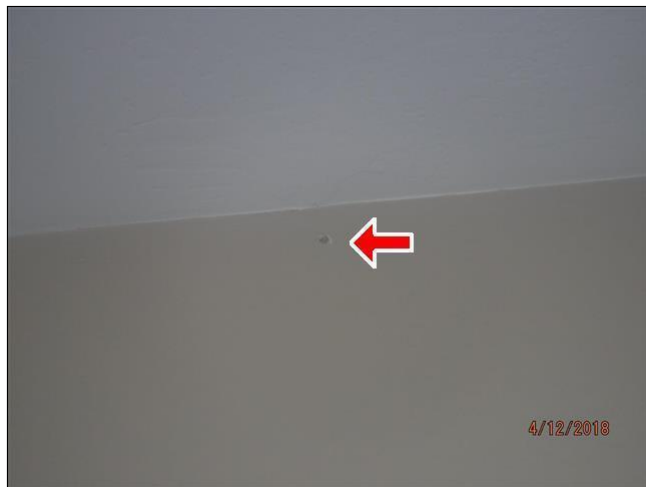
C. In the kitchen and the first story bedroom, we observed some drywall nail popping in the walls and ceiling. This is a typical occurrence in homes as building materials shift from minor structural movement. These nail pops can be repaired. For more information, see [this article](http://www.capitalgazette.com/cg-on-the-level-determine-whats-causing-drynail-pops-20140730-story.html).

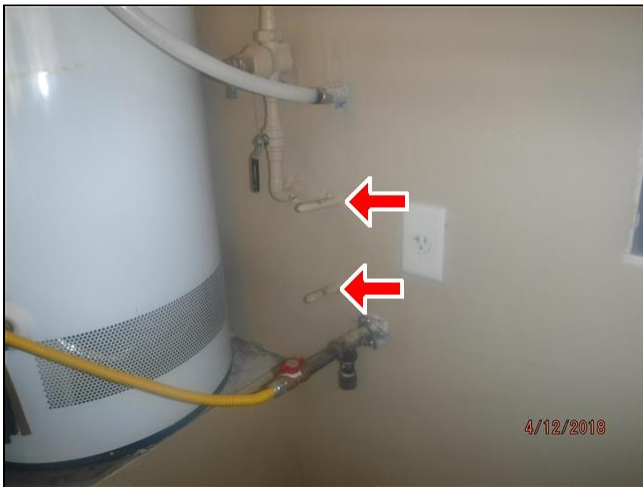
A.

(2) FYI: In the garage near the water heater, there is are some sealed copper water pipe ends protruding from the wall. This piping is likely roughed in plumbing for the installation of a recirculating pump on the supply side of the main plumbing system.

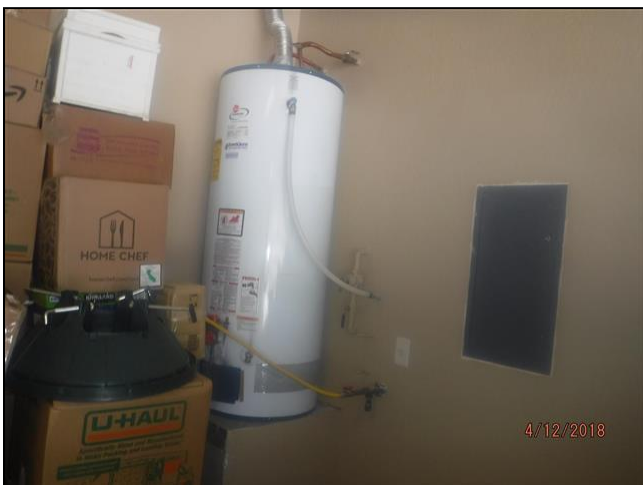
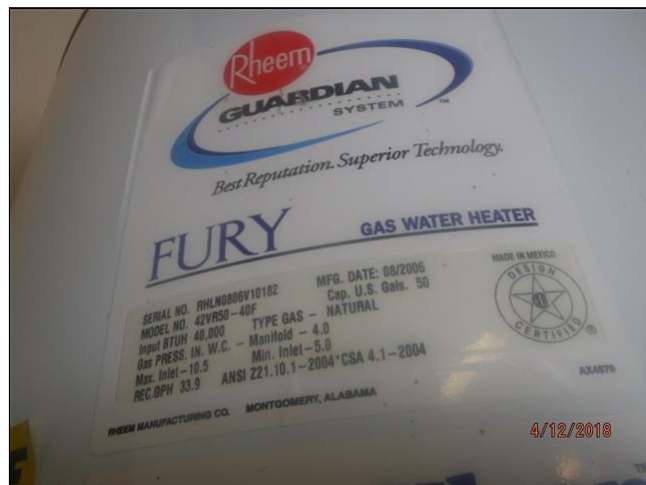
E.

This water heater was manufactured in 2006. These water bearing appliances typically last 13-17 years. This unit is about 12 years old.

There is a gas shut off valve adjacent to the unit for emergency shut off purposes.

🔍 (2) Having a drip pan installed under a water heater is beneficial because all water heaters leak when they reach the end of their serviceable life. A drip pan installed under a water heater is required only when the unit is installed inside the home. We recommend considering installing a drip pan to prevent a water mess when this water heater leaks.

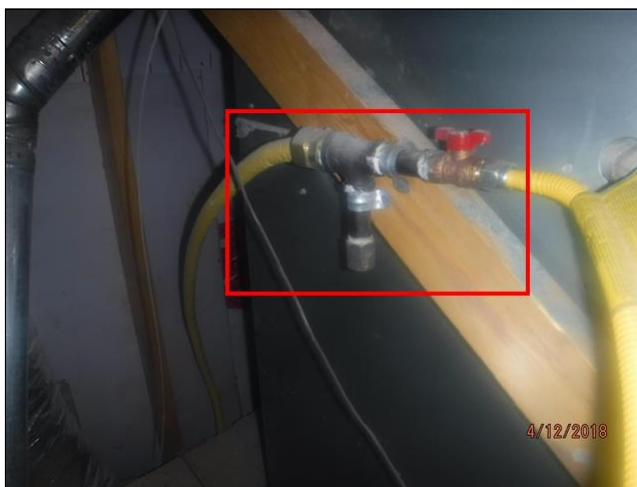
I. (1) At the furnace and the water heater, we observed that the sediment trap installed into the supply gas lines was done incorrectly. A sediment trap is a leg of piping that extends downward vertically from the supply line as close to the appliance as possible. It is designed to catch any sediment that makes its way into the gas line (see picture below). Client is advised to have a competent plumbing person re-install the sediment traps into the appliances' supply lines according to the current standards of the industry.

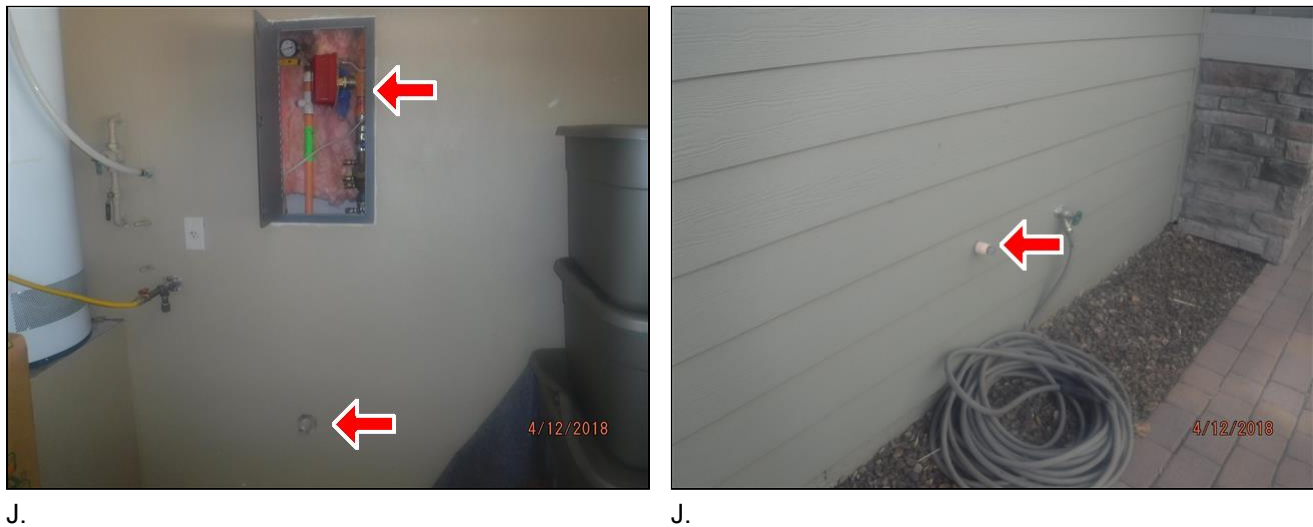
- I.
- J. FYI: We observed all the components of a sprinkler system installed in the home. There is typically a new sticker put on the main unit after each inspection. The date on the current sticker suggests that this system has not been inspected since 2006. To test the system, client is advised to consult the local fire station for more information.

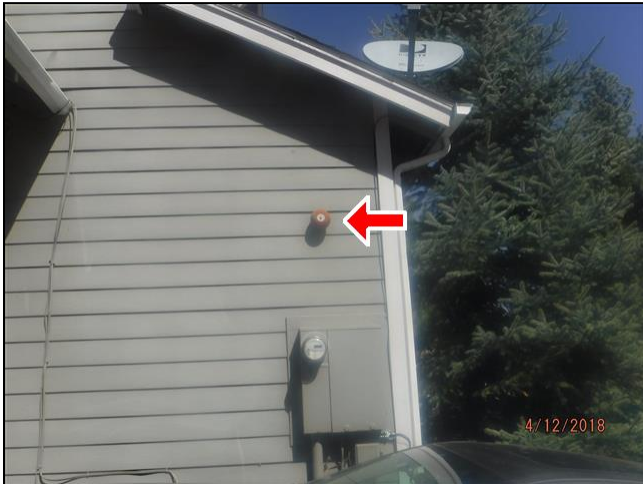
A. FYI: This home is equipped with an exterior fire alarm system. It appears that this community requires these alarm systems installed on every home. For further questions, we recommend consulting with the community office.

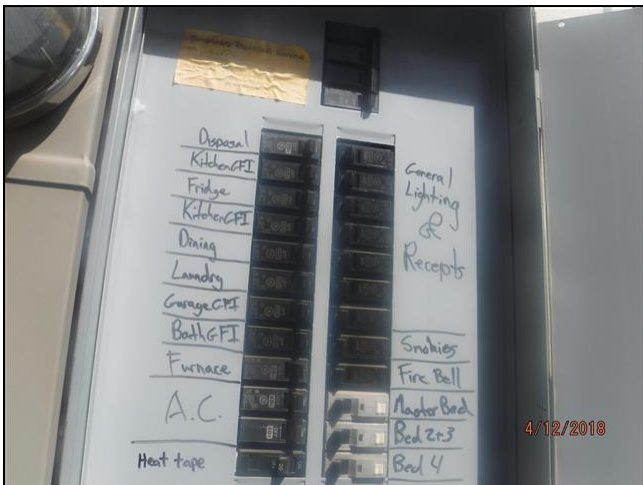
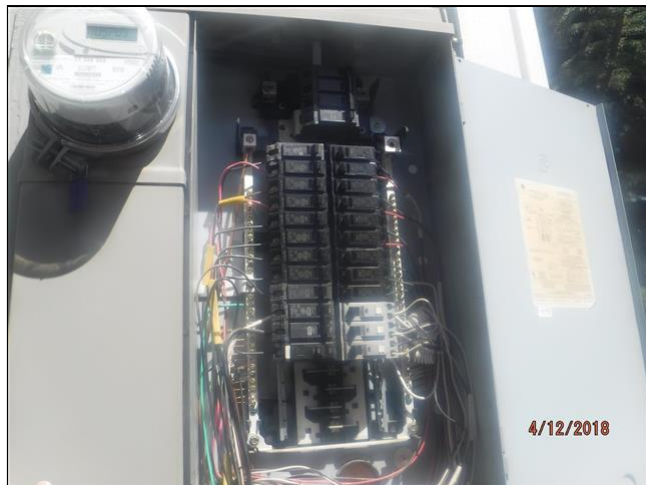
C. We observed that the main electrical panel was labeled legibly, secured well, and not missing any plates, covers, or plugs.

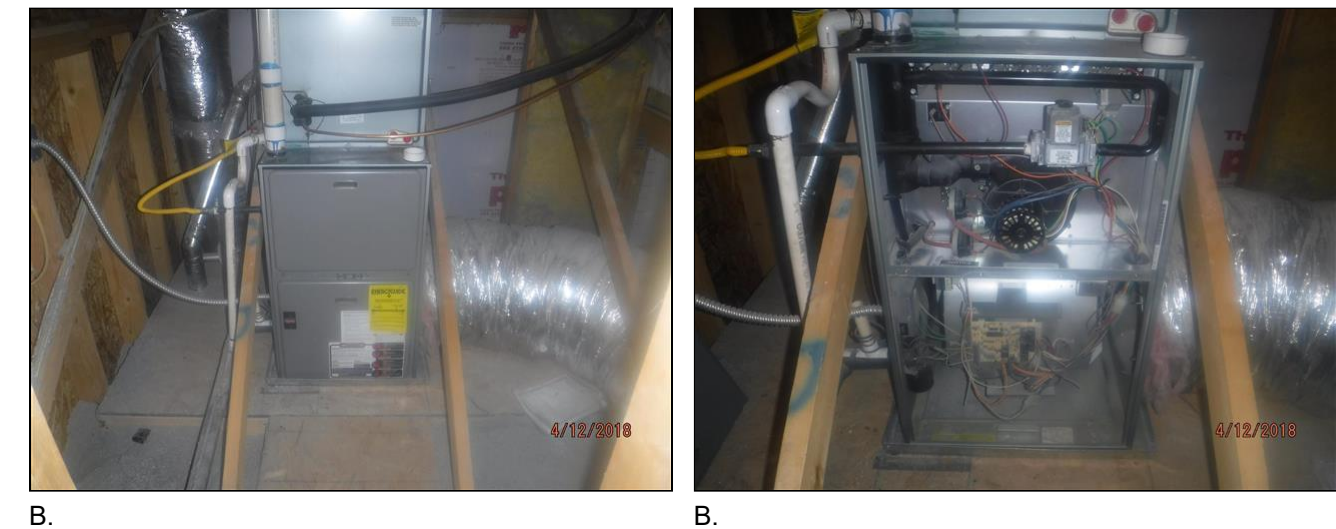
The furnace is located in the attic. It is a high efficiency furnace meaning that at least 90% of the heat that it creates is distributed through the home.

There is a gas shut off valve adjacent to the unit for emergency shut off purposes.

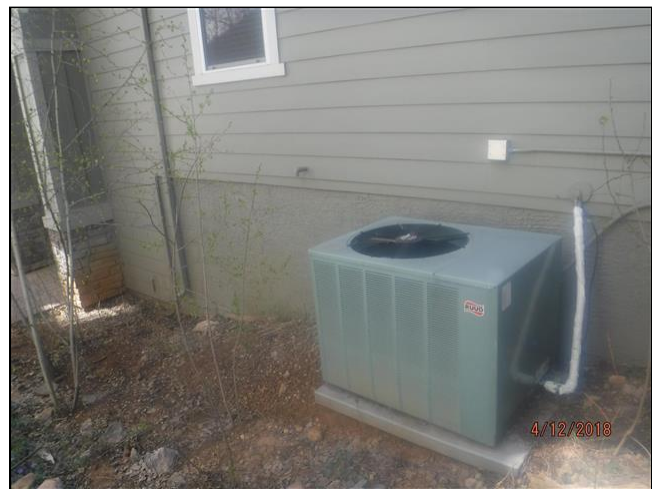
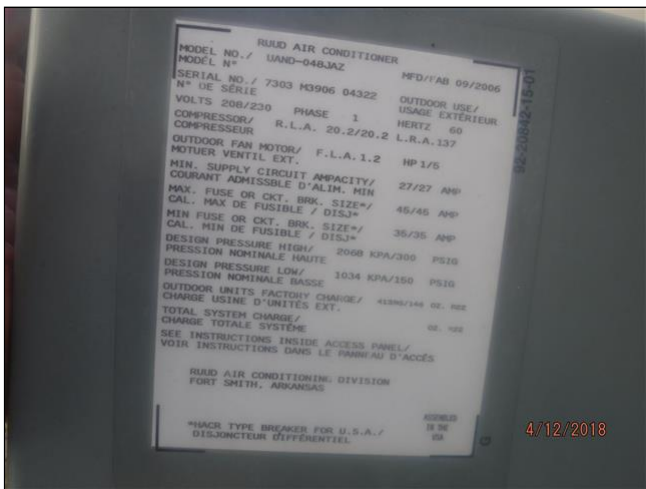
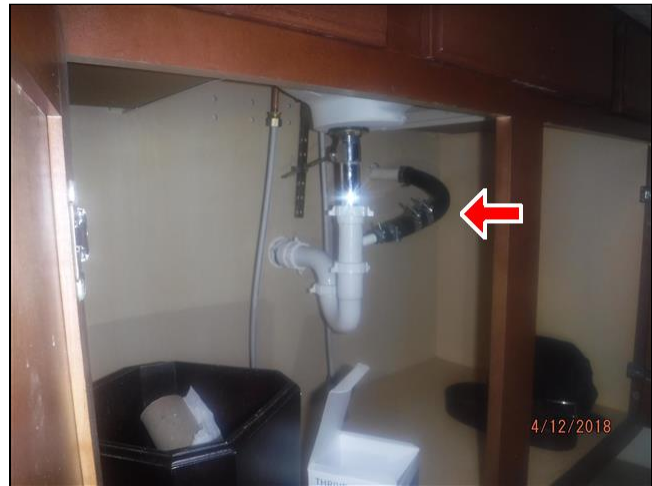
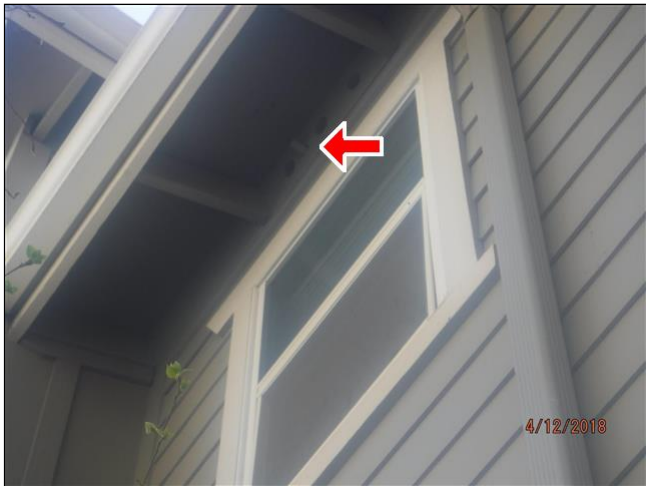
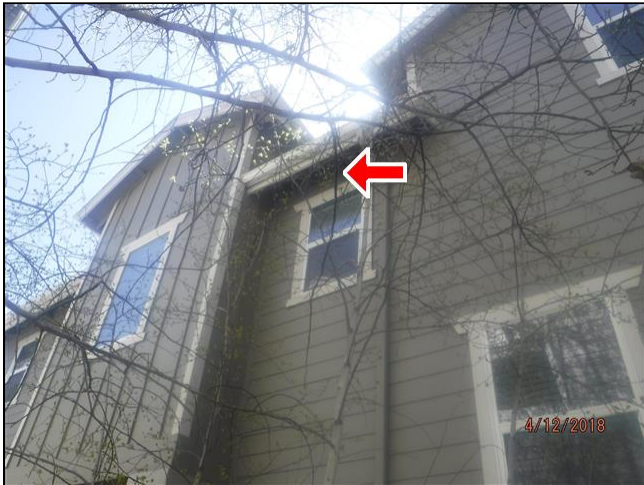
(2) We observed insulation in the condensate drip pan. If condensate were to enter the pan, it could move the insulation to the drain hole and block the drain. This may lead to the pan backing up, overflowing, and leaking through the ceiling. We recommend a competent person clean all insulation out of the pan.

C. (1) The air conditioning system operated as intended.

When an Air Conditioning compressor unit is installed for cooling home air, it uses the furnace as an air handler. Thus, the ductwork for both the heating and the cooling is the same. When changing the temperature of the air in a home, a condensate liquid usually forms. The air handler is designed to drain this condensate through a primary drain line that terminates to the drain piping under a sink in a bathroom. There is also a secondary condensate drain pan underneath the furnace/air handler that is used as a backup in case the primary condensate drain line fails. There should never be insulation in this drain pan because insulation can clog the drain of the pan resulting in potential backup and overflow into the attic and through the ceiling. The secondary pan's drain line terminates over the window in the stair well between the great room and the master bedroom floor. If you ever see a fluid dripping over that window, have a competent heating and cooling person evaluate your air handler.
